## Determination of the Rotational Direction of an Angle Grinder Based on the Tool Marks

By: Bert Weimar, Bundeskriminalamt, Forensic Science Institute, Marks Department, D-65173 Germany, Email: bert.weimar@bka.bund.de

*In a case of a fatal accident in a chemical plant the rotational direction of the involved angle grinder's wheel needed to be determined. This article describes the criteria used to answer this question based on the tool marks.*

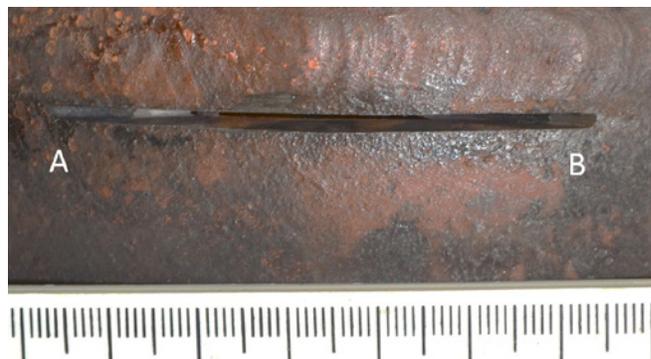
**Figure 1** is a picture of the cut. The ends of the cut were named here with the letters "A" and "B".

**Figure 1: The cut in the pipeline with notations of its ends**

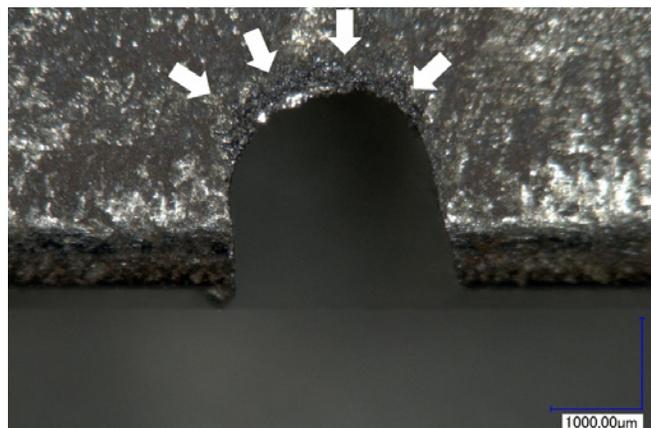
-Agglomerations of material (probably abrasion dust from the grinding wheel) on the end of the cut where the grinding wheel entered the workpiece (**Figure 2**)

**Figure 2: Insertion side of a test cut (rotational direction is away from the observer). The arrows highlight dark agglomerations**

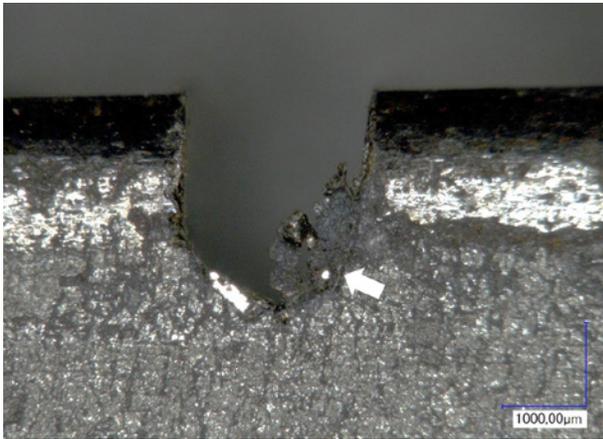
**Figure 3: Test cut where grinding wheel left the workpiece (rotational direction is toward the observer). The arrow highlights the ridge**

-Ridges on the end of the cut where the grinding wheel left the workpiece (Figure 3)

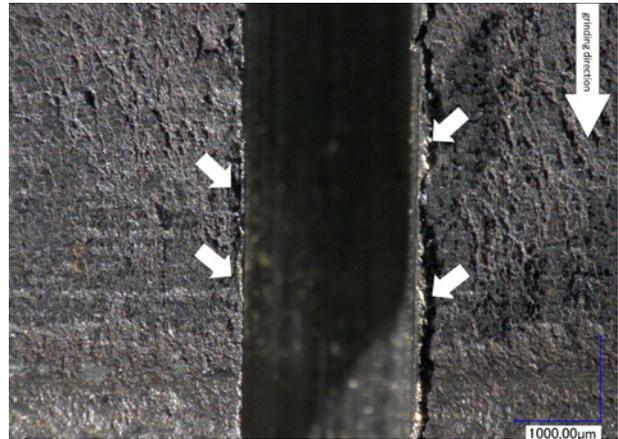
-Orientation of chips on the edges of the cut (Figures 4, 5 and 6)

The orientation of the chips, shown in Figures 4 and 5 is not always clear. In the test cuts, the majority of the chips had the same orientation relative to the grinding direction, but chips with opposite orientation were observed as well. The side of the cut on which the grinding wheel left the work piece, contained the majority of chips and they mainly showed the displayed orientation. But on the other side of the cut – the side where the grinding wheel moved into the work piece - there were chips with opposite orientation, but to a smaller extent (Figure 6). Because of this observation, this single criterion in determining the rotational direction should be used with caution.

**Figure 4: Edges of a test cut (rotation direction is downward). The arrows highlight some chips with a preferred orientation**

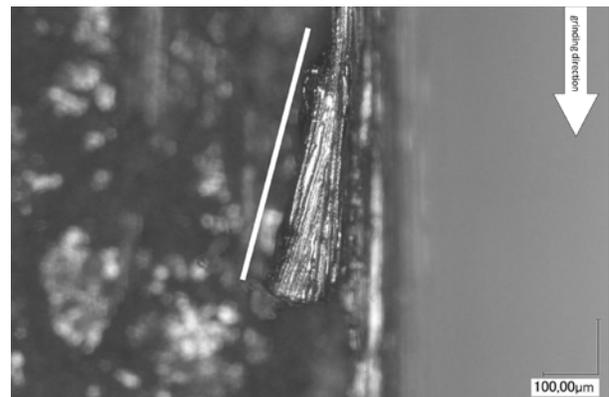
**Figure 5: Chip on edge of test cut (rotational direction is downward). Grinding marks are visible. The line highlights the orientation of the chip and the grinding marks**

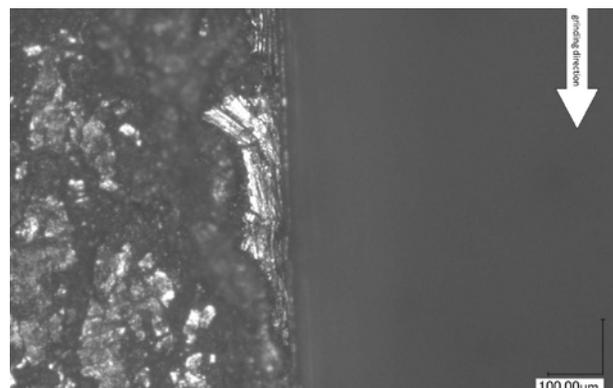
**Figure 6: Edge of a test cut (rotation is downward). Grinding marks are visible on the chip in the center. The orientation of the chip is opposite to the one in Figure 5, despite the same grinding direction**

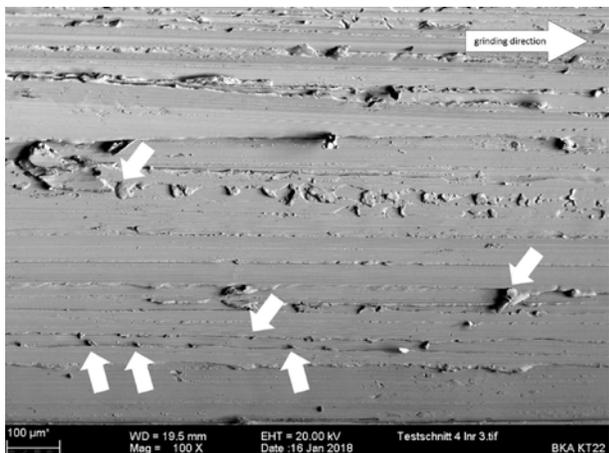
-Direction of cracks between chips and work piece on the ground of the cut (Figures 7 and 8)

**Figure 7: Bottom surface of a test cut (rotational direction left to right). Some chips which have been raised, but not totally separated from the workpiece, are highlighted with arrows. The cracks between the chips and the workpiece roughly point along the rotational direction of the grinding wheel**

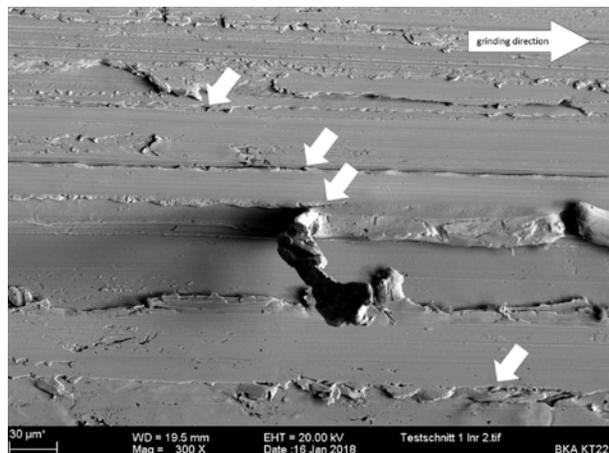
**Figure 8: Bottom surface of a test cut at higher magnification (rotation direction left to right). The arrows highlight chips raised, but not totally separated, from the workpiece. Cracks between the chips and workpiece roughly point along the rotational direction of the grinding wheel, as does the large chip**

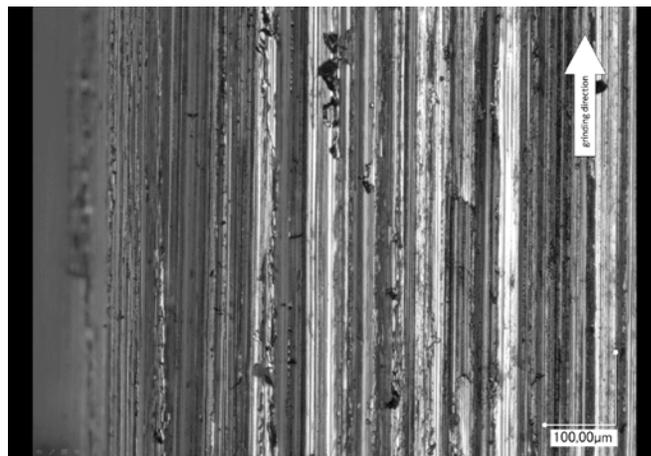
By light microscopy it was not possible to gain an image of the bottom surface of the cut with sufficient resolution to identify the details visible in the SEM pictures. Figure 9 is an example of a light microscopic image of the bottom surface

of a test cut. Casting with silicone rubber did not improve the visibility. Please note that the magnification of **Figure 9** is higher than of **Figure 7**.

**Figure 9: Photomicrograph taken with light microscope of the bottom surface of a test cut (rotational direction of the grinding wheel: upward)**

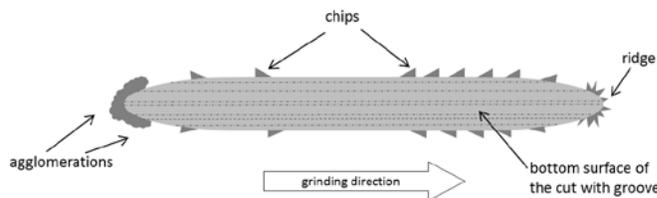
The four criteria are summarized in **Figure 10**.

**Figure 10: Schematic diagram of a cut with the described features**

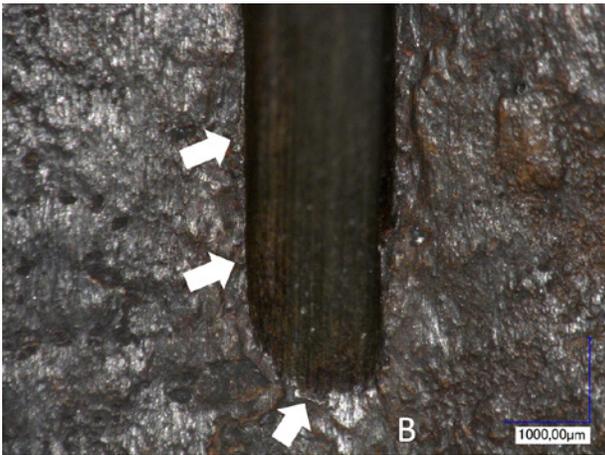
The cut in the pipeline was initially examined with a light microscope without damaging the item. **Figures 11 and 12** are the results of that examinations.

The conclusion in the case report stated: “The features found by the light microscopic and scanning electron microscopic examination (ridges, orientation of chips, agglomerations, cracks between chips and workpiece) consistently indicate that the surface of the grinding wheel, which had direct contact with the workpiece, moved in the direction from A to B”.

**Figure 11:** “B” end of the cut in the pipeline. The arrows indicate some small chips on the edges and a ridge at the end of the cut. Both criteria imply that the grinding wheel rotated from “A” to “B”

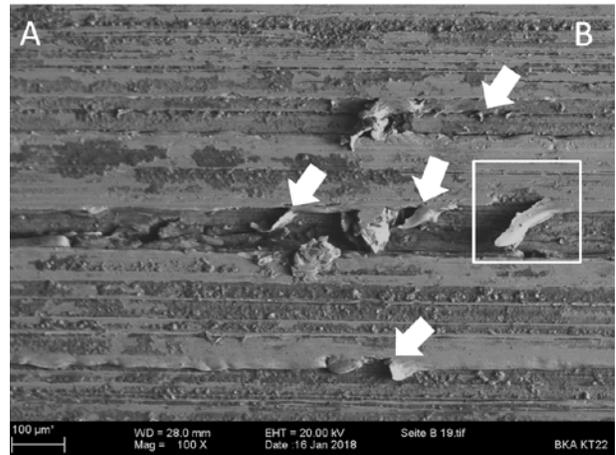
To verify the observations, the part of the pipeline with the cut was separated to enable a SEM examination. Afterwards the bottom surface of the cut was examined using the SEM. The results are presented in **Figures 13 and 14**. The results of the

SEM examination were that the grinding wheel rotated from “A” to “B”.

**Figure 13:** Bottom surface of the cut in the pipeline. The arrows indicate some chips and the cracks between them and the workpiece. In the white frame is a chip and the fracture surface from which the chip was separated and bent into the grinding direction

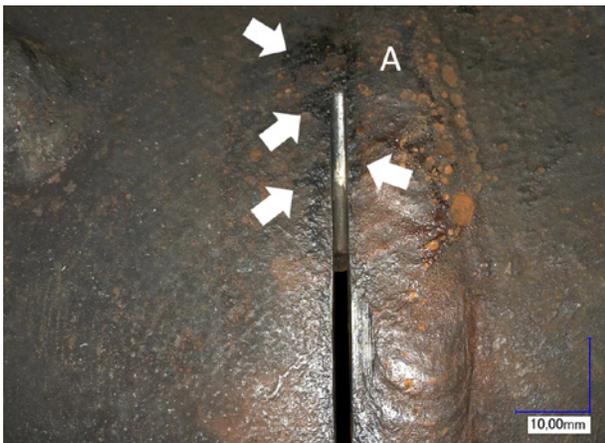
**Figure 12:** “A” end of the cut in the pipeline. The arrows indicate dark agglomerations that imply that the grinding wheel rotated from “A” to “B”

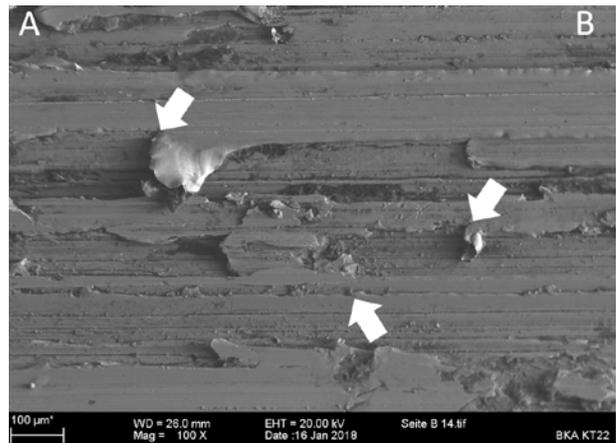
**Figure 14:** Bottom surface of the cut in the pipeline. The arrows indicate some chips and the cracks between them and the workpiece
