## The Miami Barrel Saga Continues

By: Thomas G. Fadul Jr. and Adrian Nuñez, Miami-Dade Police Department, Miami, Florida

### ABSTRACT

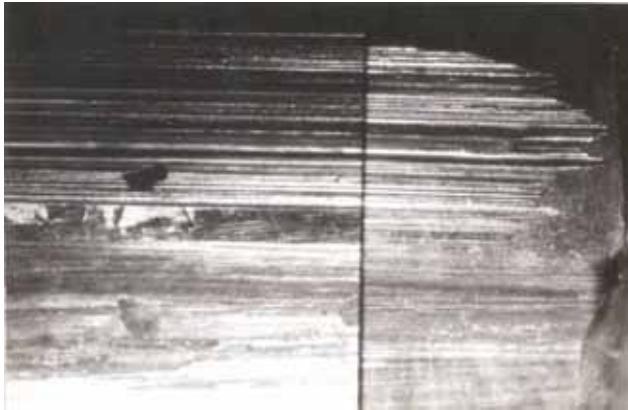
Photo 1: Comparison of bullets fired through a barrel scribed by John Matthews

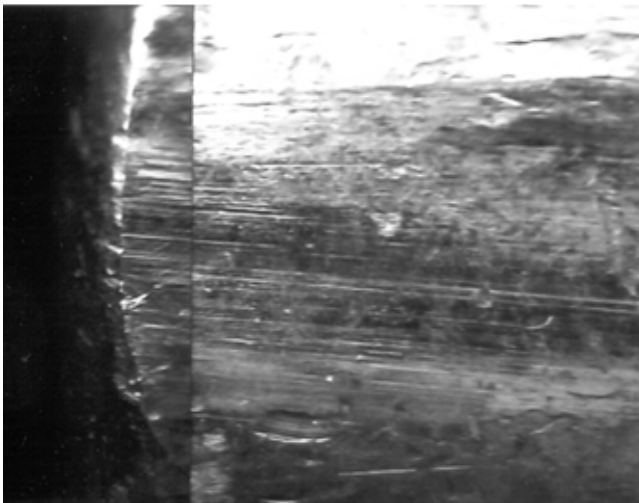
On June 15, 1994, the late John Matthews, formerly of the Royal Canadian Mounted Police (RCMP) laboratory, and a Glock representative met with lab personnel and MPD due to the concerns raised regarding Glock pistols and the inability to consistently identify spent projectiles. While at the MDPD laboratory, Matthews used a scribe to create crude toolmarks inside the barrel, which resulted in a personal signature for each (photo 1). This meeting led Glock Inc. to modify their traditional gun barrel using the Electronic Spark Reduction Method (ESRM) which resulted in "The Miami Barrel"(3) (photo 2). After testing this modified Glock barrel, the ESRM was not found to significantly enhance the identifiability of the bullets (photo 3).

Photo 3: Comparison of bullets fired through ESRM barrel

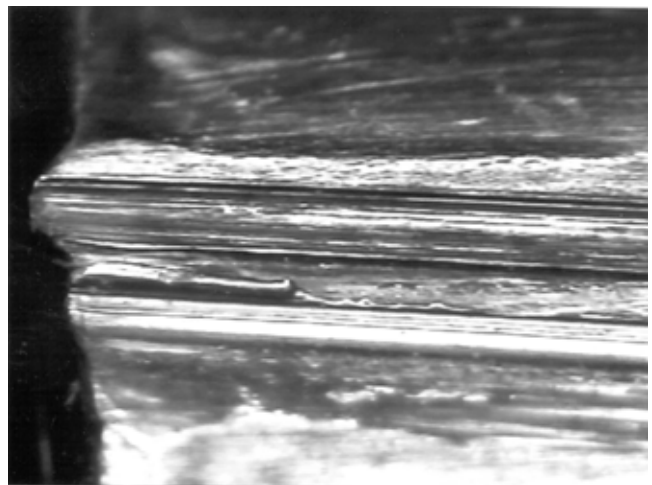
Microscopic examination revealed that projectiles fired through the barrel with serial number L18468 were marked by only one of the eight toolmarks in a manner deemed identifiable (photo 4). With regards to projectiles fired through the second barrel with serial number L18469, two of the eight toolmarks left identifiable markings.

Photo 4: Bullet depicting toolmark imparted by chisel-like tool

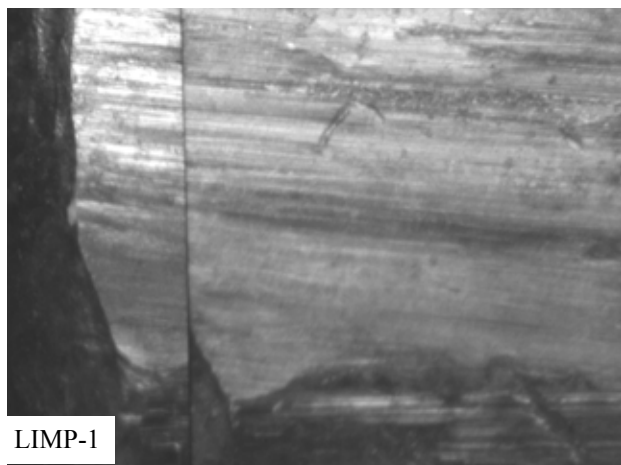
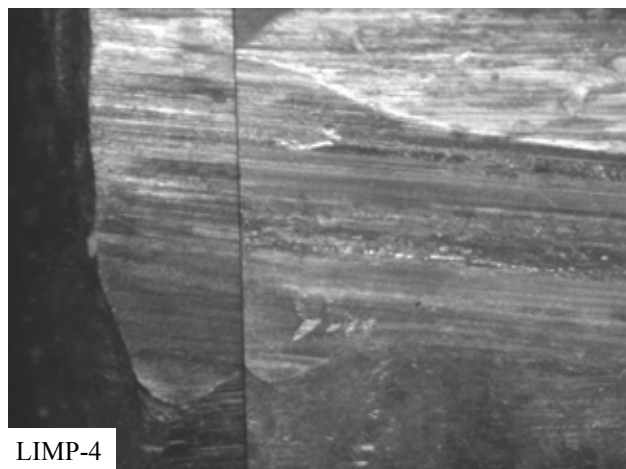
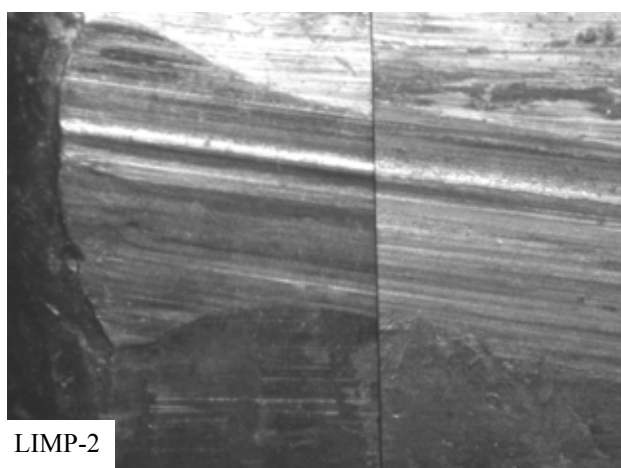
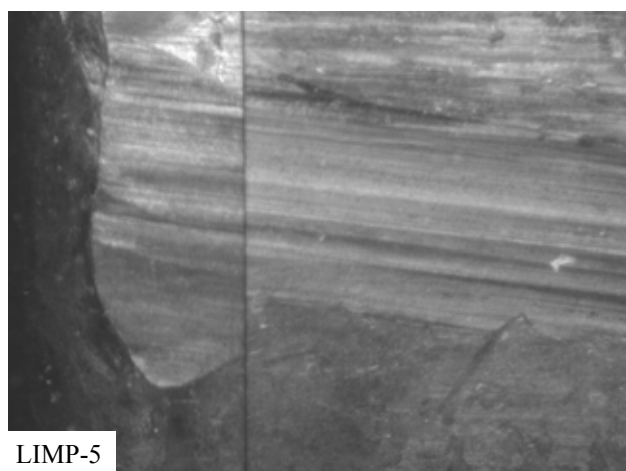
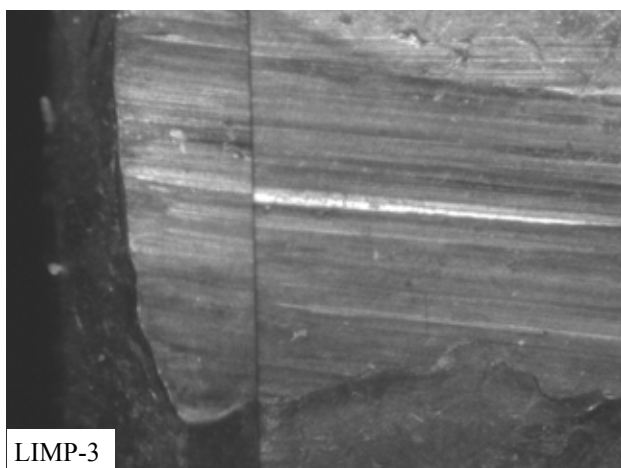
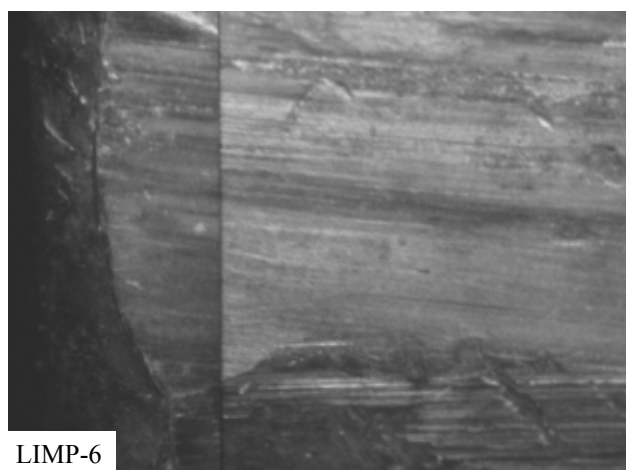
Photo #5: 40 S&W Glock barrel,  
serial number L20075,  
rounds #26 and #27

Photo 5: Six land impression comparisons deemed not readily identifiable

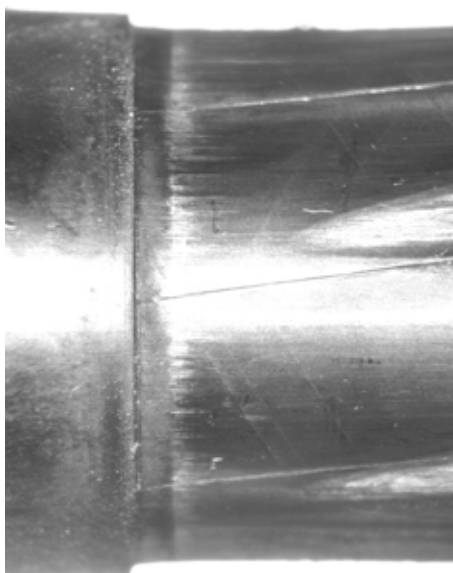
Photo 6: Cross section of barrel.

Casts were made of five barrels using hydrophilic vinyl polysiloxane (silicon rubber) casting material, brand name Elite H-D, and an extrusion gun. Luke Haag's testing of this material found it suitable for casting the bore of barrels. (6) One barrel was cross-sectioned and examined (photo 6). Under the stereomicroscope, eight fine lines running the length of the barrel were visualized (photo 7). A tool is most likely pulled or pushed through, then the configuration is changed for the next barrel. According to a BATF source, the tool is started at the 12 o'clock position for the first barrel, then changed for each barrel. The tool appears to twist with a similar pitch as the rifling; it flows along with the land and grooves. Glock advised that the tool is pending patent approval and no further information was available.

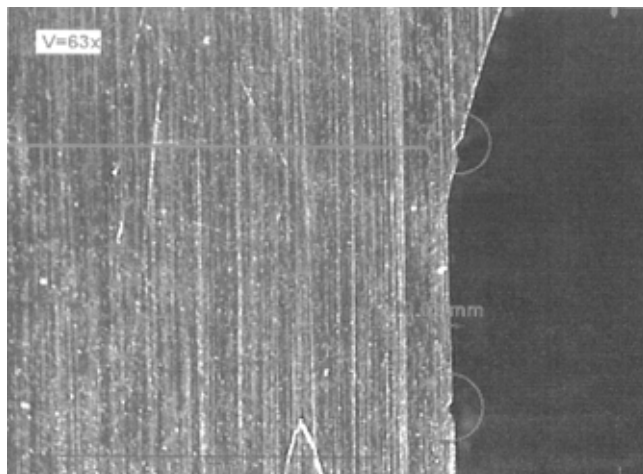
change their specifications to meet our requests, and suggested that a future possibility to consider involved bar coding the barrels. Pictures 8 and 9 (courtesy of Mr. Hirscheiter) depict a cross-section view of the cut produced by the Glock tool and the mark left on a bullet.

Photo 8: Cut in barrel produced by Glock tool

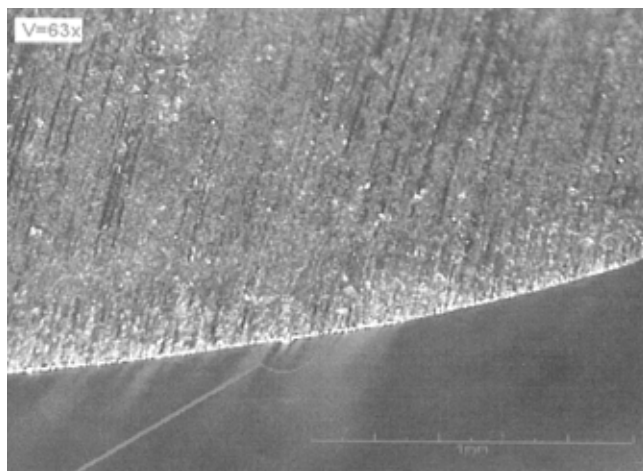
Photo 9: Mark left in bullet from cut in Photo 8

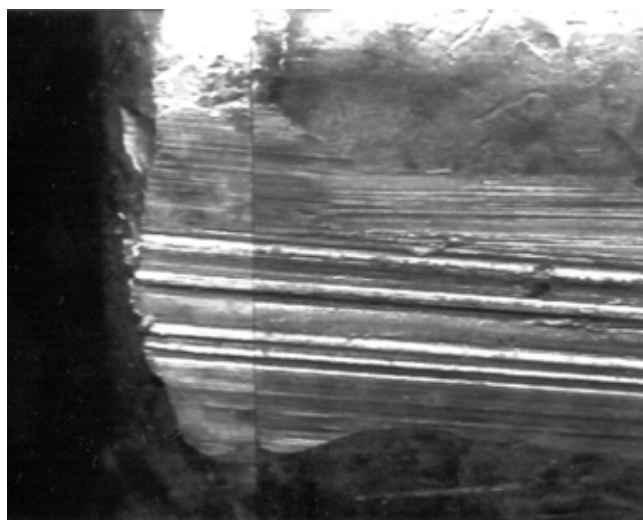
Examination under the comparison microscope found these lines do reproduce as gross marks on the bullets. These marks displayed similarities from one barrel to the next and were determined to be subclass characteristics of these new Glock barrels. Concern arose regarding the misuse of these gross marks for identification purposes.

Photo 10: Gross marks, example of subclass characteristics in phase

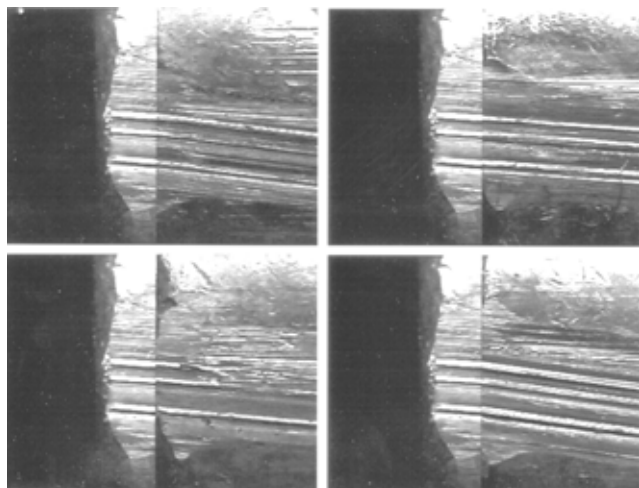
Photo 11: Gross mark comparisons, different land impressions within same barrel

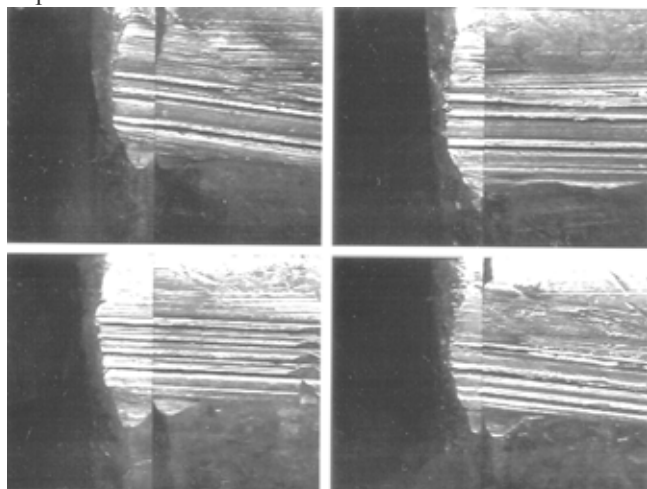
Six new barrels were received on July 17<sup>th</sup> after complying with the requests made at the prior meeting. As before, the barrels were cast and tests fired through each. Initial observations found the gross marks on the casts to be very pronounced. These same gross marks were observed under the microscope as multiple deep cuts or grooves within each land impression (photo 10). Again, concern arose relating to the repeatability of these gross marks from one barrel to the next. These gross marks were considered a subclass characteristic that these Glock barrels obtained during manufacture (photo 11). A total of nine examiners independently examined tests fired through each barrel, as well as, comparison of tests from different barrels. All examiners concluded that each barrel was readily identifiable. There were areas of gross markings that were similar from barrel to barrel (photo 12), however, they could be easily differentiated once the bullet was completely examined and individual characteristics taken into account (photo 13). The problem still existed where a damaged projectile or wear to the barrel could leave little individual characteristics and only the gross markings observed. An examiner unfamiliar with these subclass characteristics could easily misinterpret them for individual characteristics.

Photo 12: Gross mark comparisons, of two different barrels

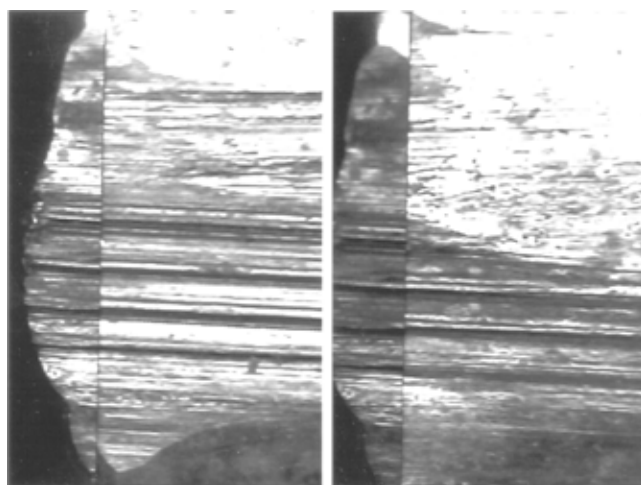
The results of the microscopic examination revealed that the bullets obtained from the above testing were found to be "not readily identifiable". It should be noted that it was possible to make a positive identification in select areas of the bullets; however, that does not meet our criteria of readily identifiable. Significant deterioration of individual characteristics could be seen as early as the 250<sup>th</sup> test fire (photos 14 and 15).

Photo 14: Comparison reference Barrel L21753: left side is bullets 26 & 27, on the right is bullets 27 & 250

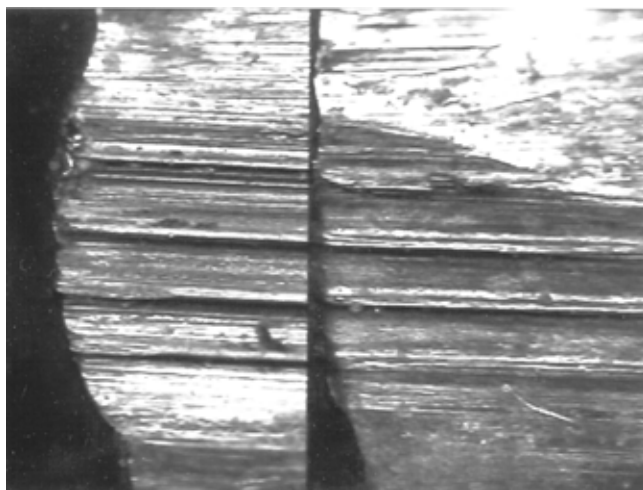
Photo 15: Close up of bullets 27 vs. 250, barrel L21753

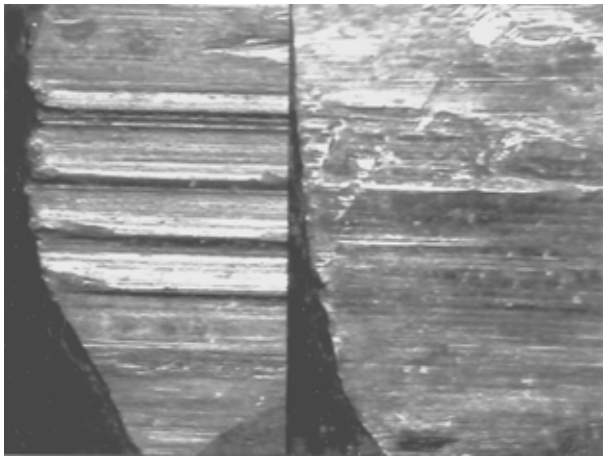
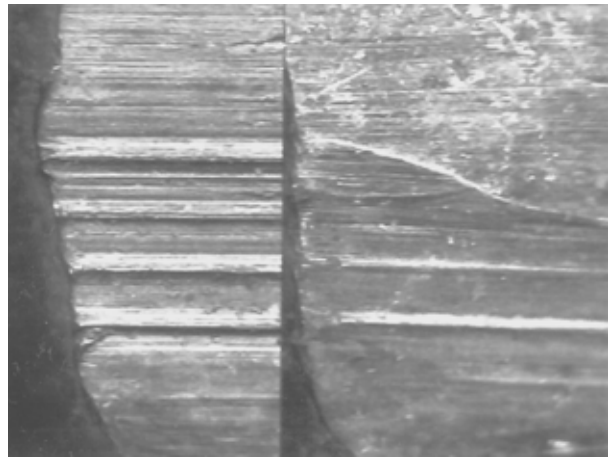
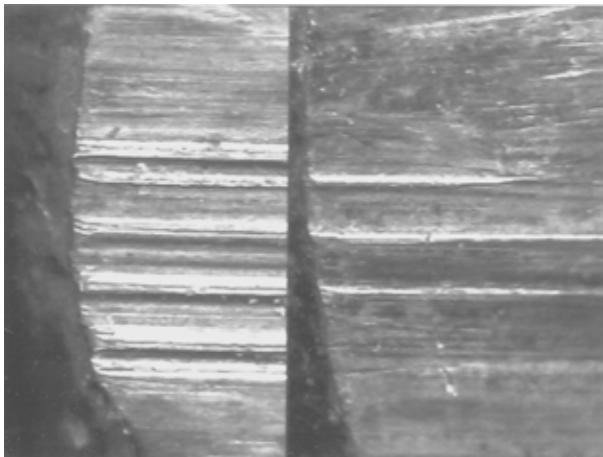
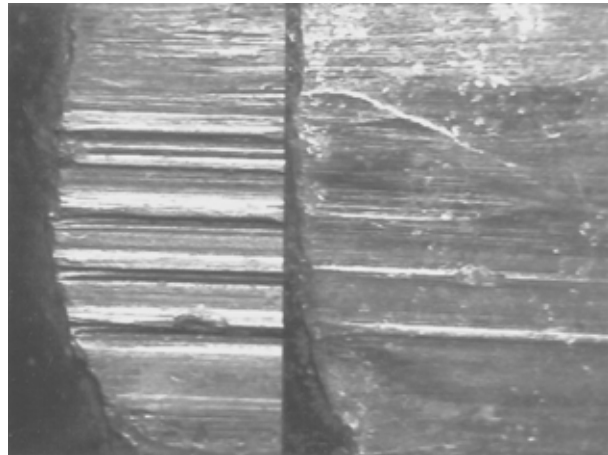
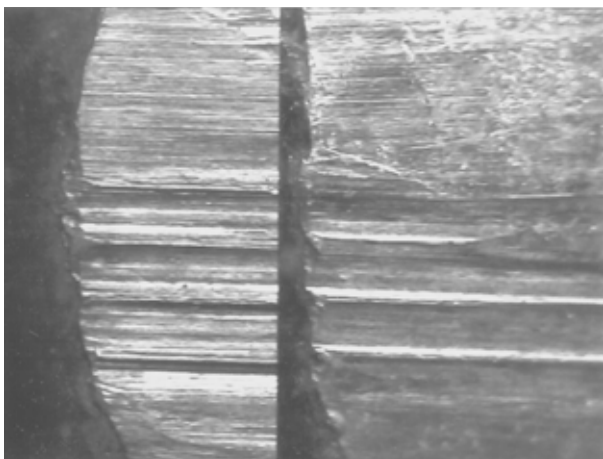
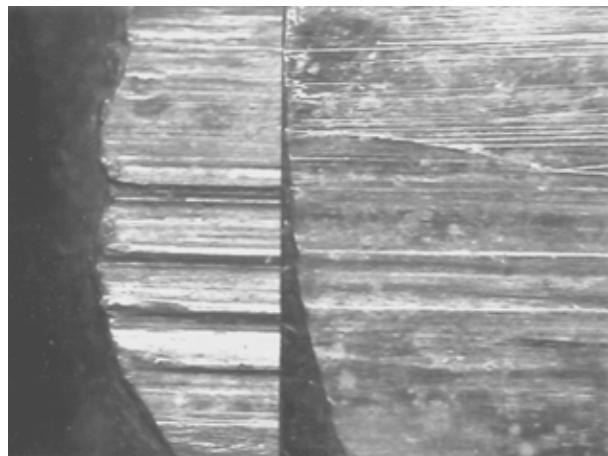
It was also noted that the gross characteristics that marked the bullets very well before the above testing failed to reproduce as it originally did. The width, depth and definition of the gross marks diminished as the testing pro-

gressed. By the 3000<sup>th</sup> round, indexing of the test fires becomes very difficult as the gross marks used prior were either hardly visible or non-existent. Pictures 16 through 21 demonstrate the loss of individual and sub-class characteristics from the initial tests compared to the final tests.

Photos 16 - 21: Exhibits the six land impressions of barrel L21753, bullets 27 vs. 3000
