Drilling Toolmarks Discovered on the Underside of an Explosively Formed Projectile Liner

By: Steve Scott, Physical Scientist, FBI – TEDAC Laboratory, Redstone Arsenal, Alabama

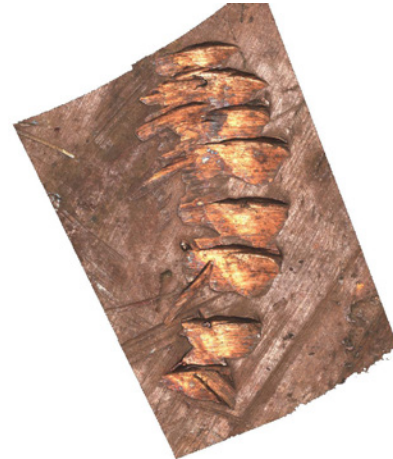
Figure 3: EFP toolmark (image taken using Alicona® Infinite Focus SI microscope)

During the recent examination of an EFP liner, toolmarks were noted on the convex side of the liner (**Figures 2-5**).

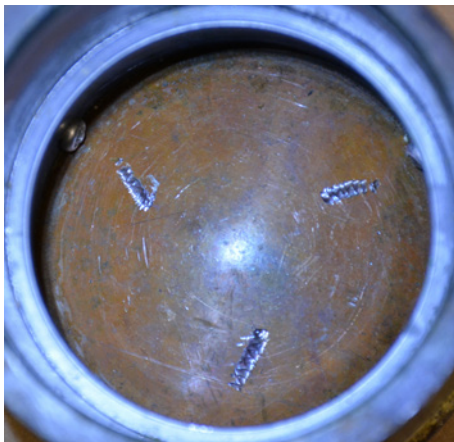
Figure 2: Toolmarks on the convex surface of an EFP liner

These toolmarks were roughly equidistant from one another, bore a shiny appearance, and did not appear to be 'aged' like the patina on the remainder of the liner's surface. At the least, this suggested that they may have been produced more recently than the original copper sheet material.

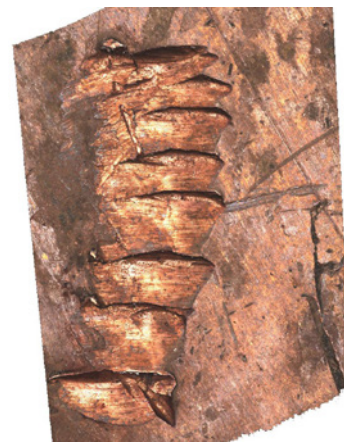
Figure 4: EFP toolmark

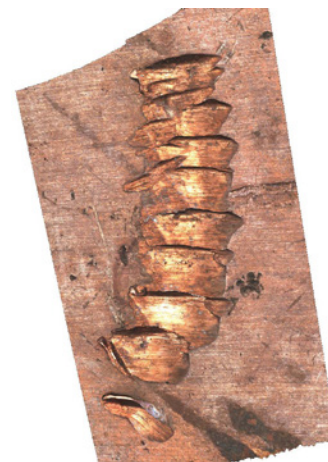
Figure 5: EFP toolmark

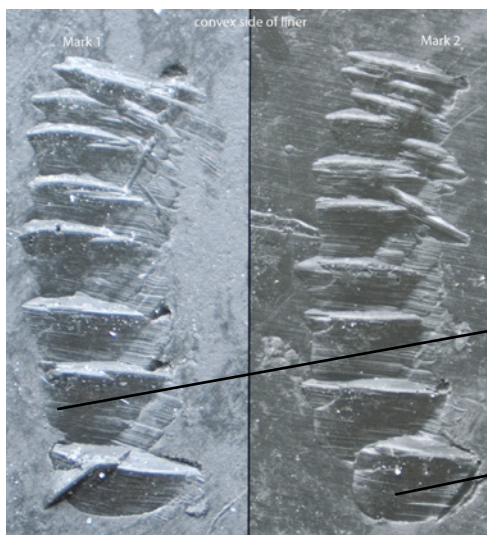
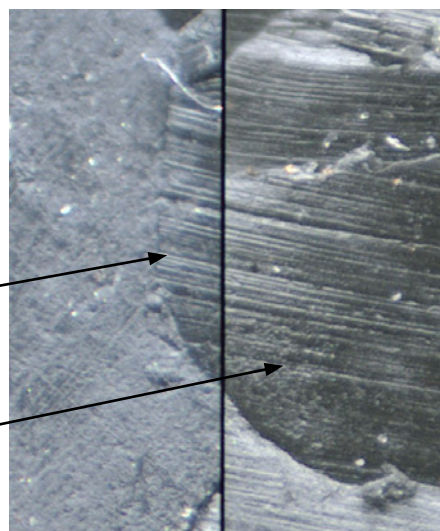
Figure 6: Two of the EFP toolmarks (taken on Leeds Forensic Systems LCF toolmark microscope)

Due to their size and shape, EFP liners are not particularly suited to being placed directly on the comparison microscope. Casting material is routinely used to capture the detail within toolmarks, so casts were made for comparison. If in fact these toolmarks were from a three-sided chuck device, then they should not be identifiable to one another, as each chuck 'element' would act as an individual tool. Soon after placing the casts on the microscope, it was clear that these were three toolmarks that had been separately created by the same tool (**Figures 6 and 7**).

Figure 7: Corresponding detail in EFP toolmarks

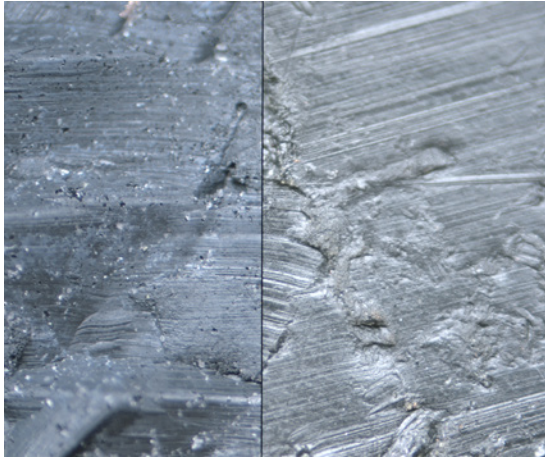
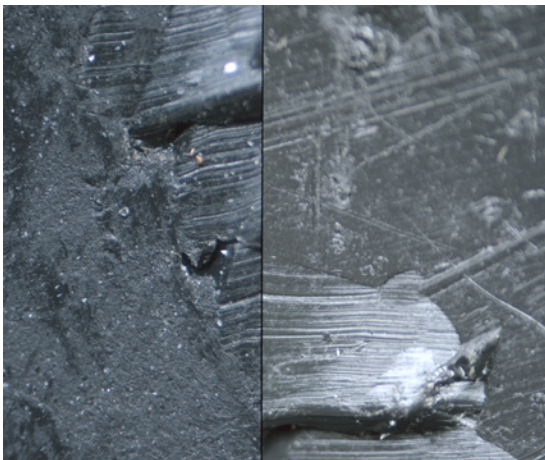
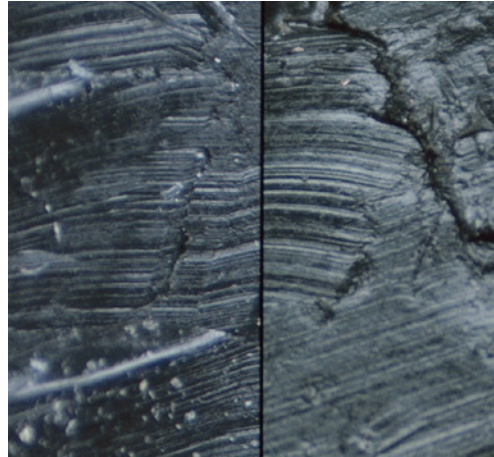
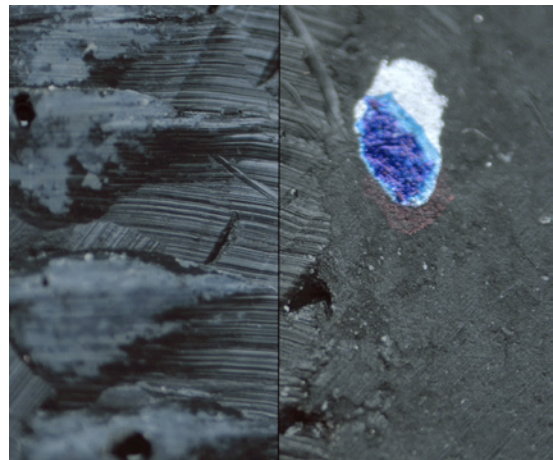
With this discovery, it was now clear that these toolmarks were likely created during the assembly process. Casts of these toolmarks were compared to the previously created casts from the disassembled device and were found to be identifiable. The toolmarks present on the three EFP liners had all been produced by the same drill bit (**Figures 8-11**).

Figure 8: Corresponding detail in EFP toolmarks

Figure 10: Corresponding detail in EFP toolmarks

Figure 9: Corresponding detail in EFP toolmarks

Figure 11: Corresponding detail in EFP toolmarks
