A Tool Mark Identification Involving Rescue Equipment Used in a Series of Burglaries

By: Sergeant Andrew Nisbet, Ballistics Unit, Victoria Police Forensic Services Centre, Macleod, Melbourne, Australia

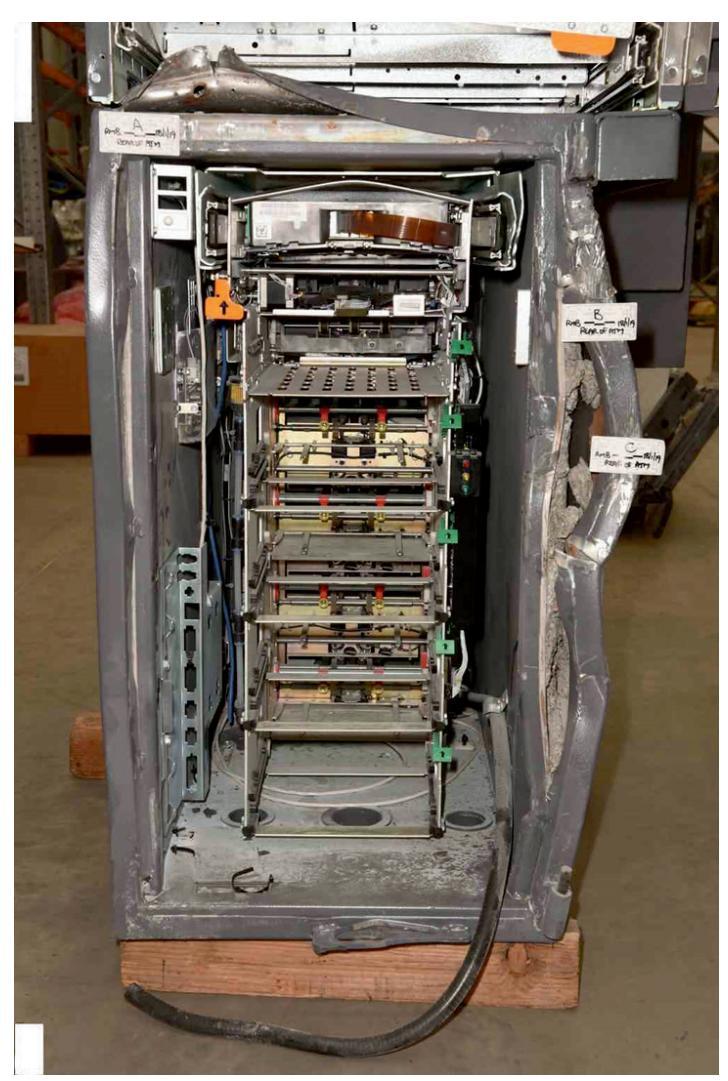
Figure 1: One of the breached ATMs with tool marks indicated by white scale labels

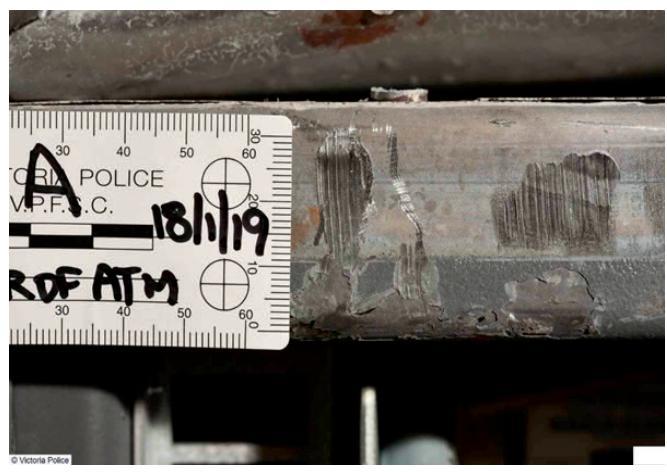
Figure 2: An example of some of the striated tool marks with scale

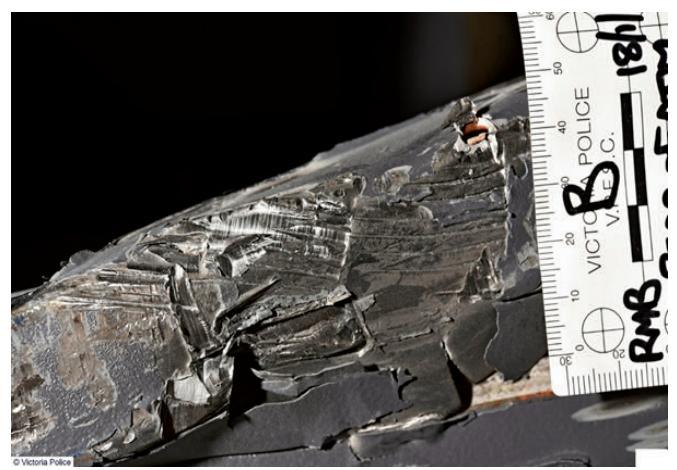
The casts showed a range of impressed and striated tool marks with varying depths, widths and angles of attack. Notably, on the two ATMs that had been successfully breached, the casts showed a number of combination tool marks (impressed and striated) which featured multi-toothed impressions with up to seven individual teeth approximately three millimetres (0.118") apart (**Figure 4**). Other markings showed the width of the teeth as approximately 36 millimetres. (1.417"). Fine striated individual characteristics were observed in each tooth impression cast, with striae running perpendicular along the impression. These individual striae were formed from movement of the teeth as they impressed into the metal (**Figure 5**).

Figure 3: Overlapping multi-toothed tool marks observed on a breached ATM with scale

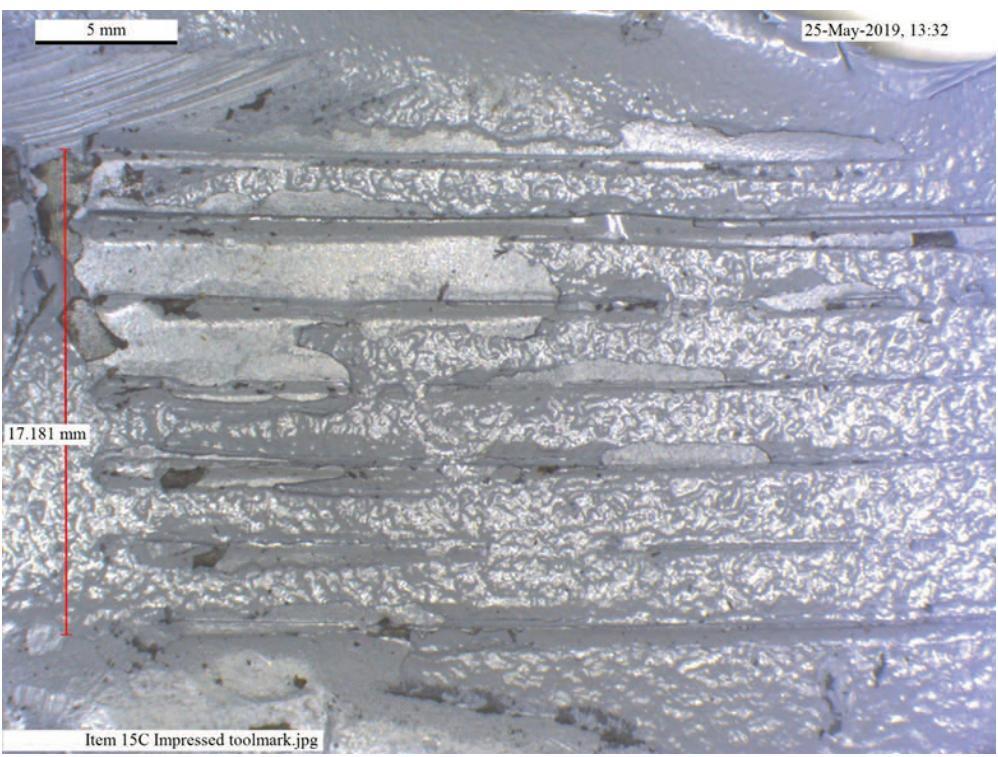
Figure 4: A Forensic-Sil cast of multi-toothed impressed tool marks taken from one of the ATMs

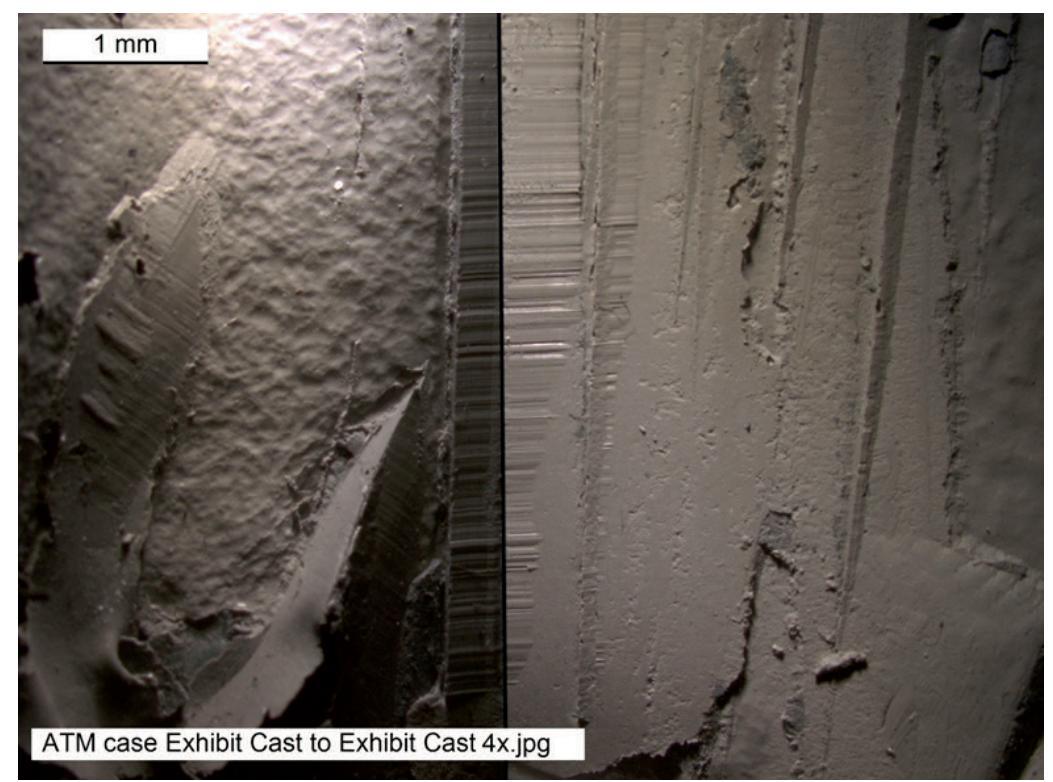
Figure 5: Comparing casts of two exhibit tool marks to each other from the same ATM, with striated information visible in the marks running perpendicular to the impression

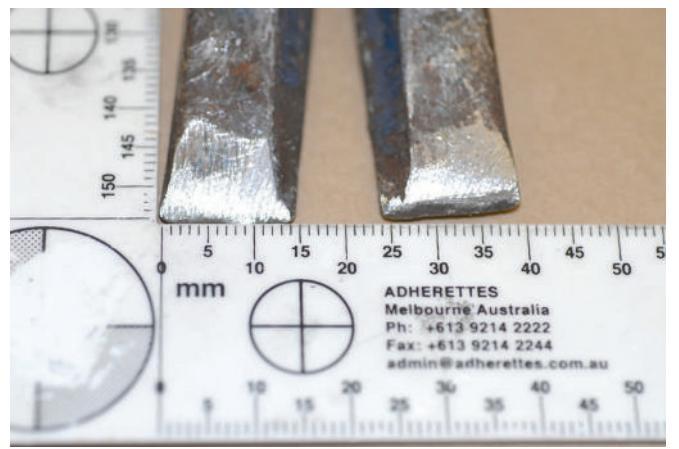
observed that the tips of the wrecking bars had been recently machined, in an apparent attempt to alter the working surfaces of the tools and obliterate marks that could be used for tool mark comparison (**Figure 6**).

Figure 6: The tip of one of the wrecking bars examined. Recent machining marks are observed on the tips in an apparent attempt to obscure or obliterate tool marks left by the tool

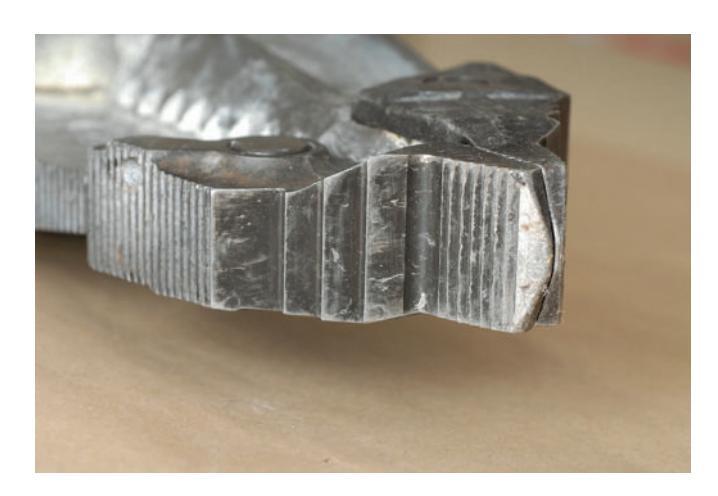
Examination of the EFORCE device spreader head showed that the metal of the tips of the jaws featured stepped teeth along the outer sides (**Figure 8**). Closest to the jaw tips there were seven teeth, each approximately 3 millimetres (0.118") apart (**Figure 9**). The width of the jaw in the area where the teeth were present measured 37 millimetres (1.46") in width. The tool jaws exhibited class characteristics consistent with the tool or tools used to create the marks seen in the casts from the breached ATMs.

Figure 8: The jaw tips of the exhibit EFORCE device

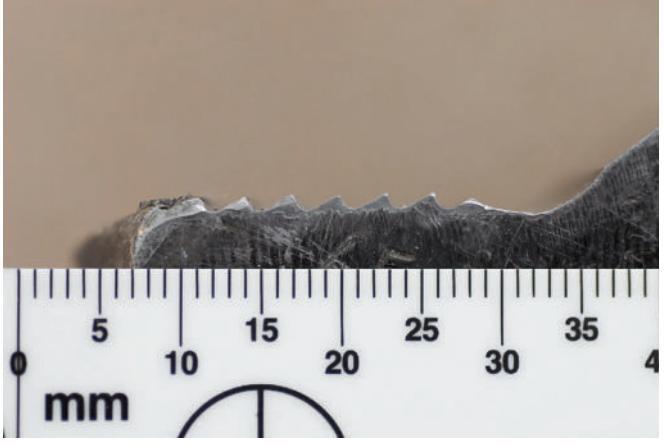
There were multiple areas of damage and wear observed on the teeth, and the jaws had clearly seen a lot of use. The profile or peaks of the teeth had worn, with the teeth closer to the jaw tips being more worn and rounded than the rear three teeth that appeared to have seen less use and suffered less accumulated wear. A cast was taken of the teeth and examined, where it was observed that the damage and wear featured differently between the individual teeth (Figure 10).

Figure 9: The teeth closest to the jaw tip with their spacing at approximately 3mm apart. The tips closer to the front of the jaws show more random wear than those further back

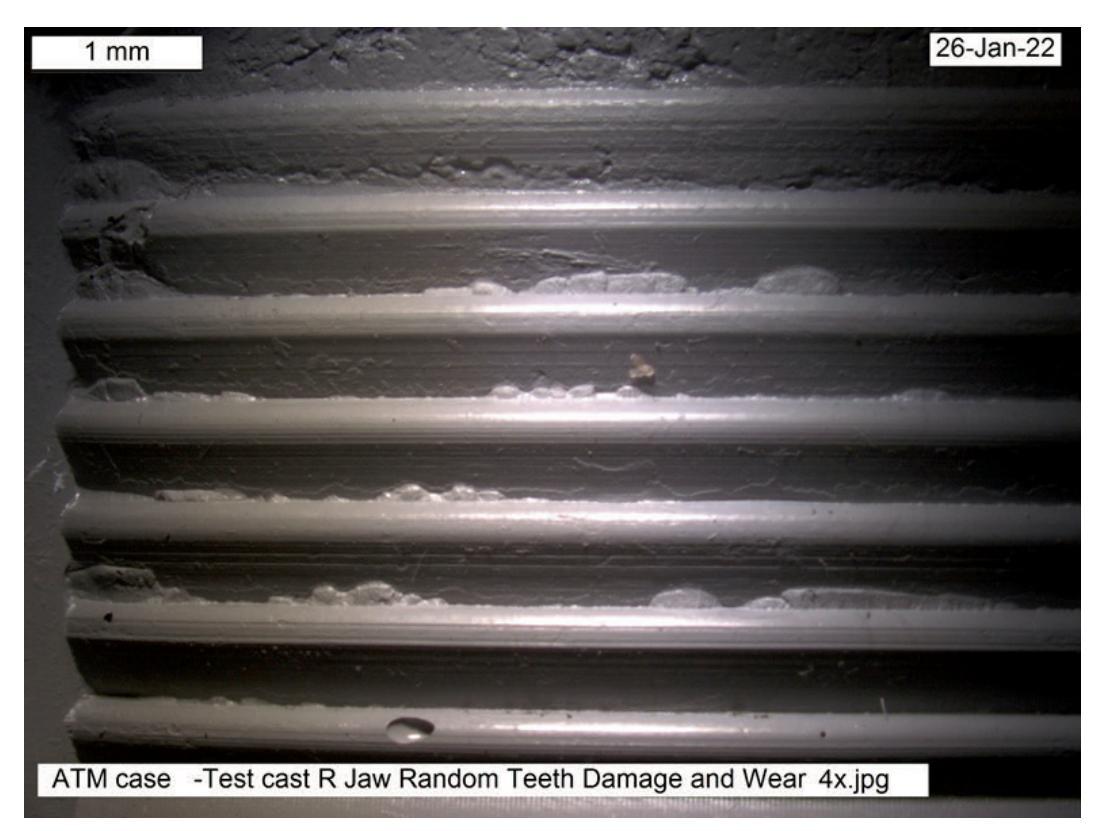
Figure 10: A Forensic-Sil cast taken from the teeth near the front of the right jaw, with random accidental damage observed across multiple teeth

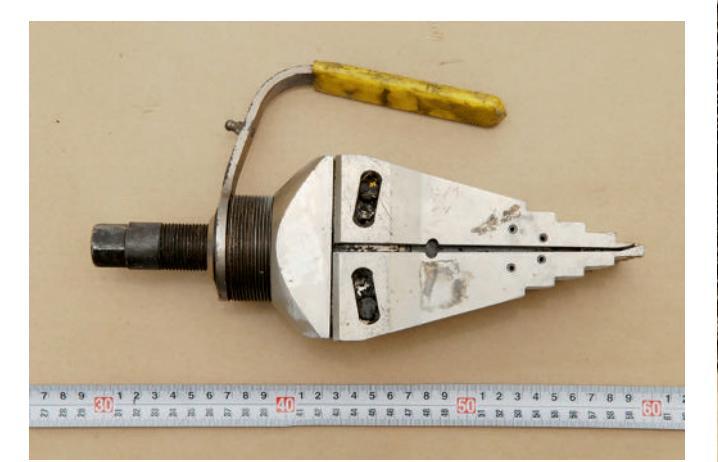
The second spreader head width measured 70 millimetres (2.756") and it presented four stepped teeth on each jaw, with a tooth length of 10 millimetres (0.394"). The jaw tips each held three offset blocks each measuring 10 millimetres

Figure 11: The detached exhibit spreader head that was eliminated through differing class characteristics

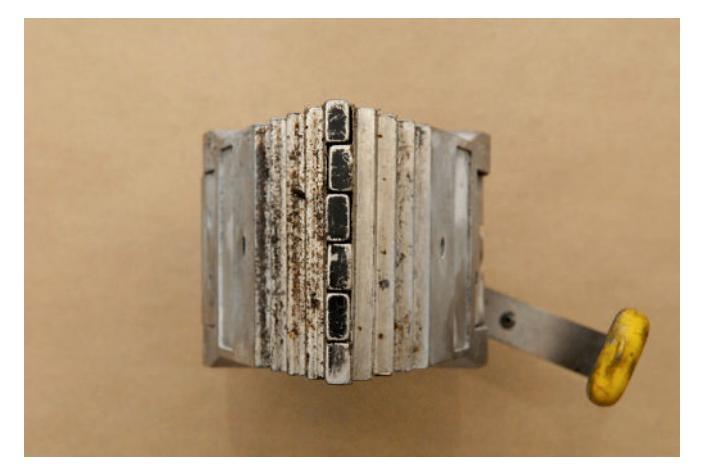
(0.394") that interlocked to the front when the jaws were closed. When the jaws were opened, a pointed metal ram was produced with a single blade edge measuring the width of the second spreader head. The class characteristics of the second spreader head were vastly different from those observed as impressed into the ATMs and as a result it was eliminated as a possible source of the tool marks (Figure 12).

Figure 12: The jaw tips of the exhibit spreader head that were eliminated through differing class characteristics

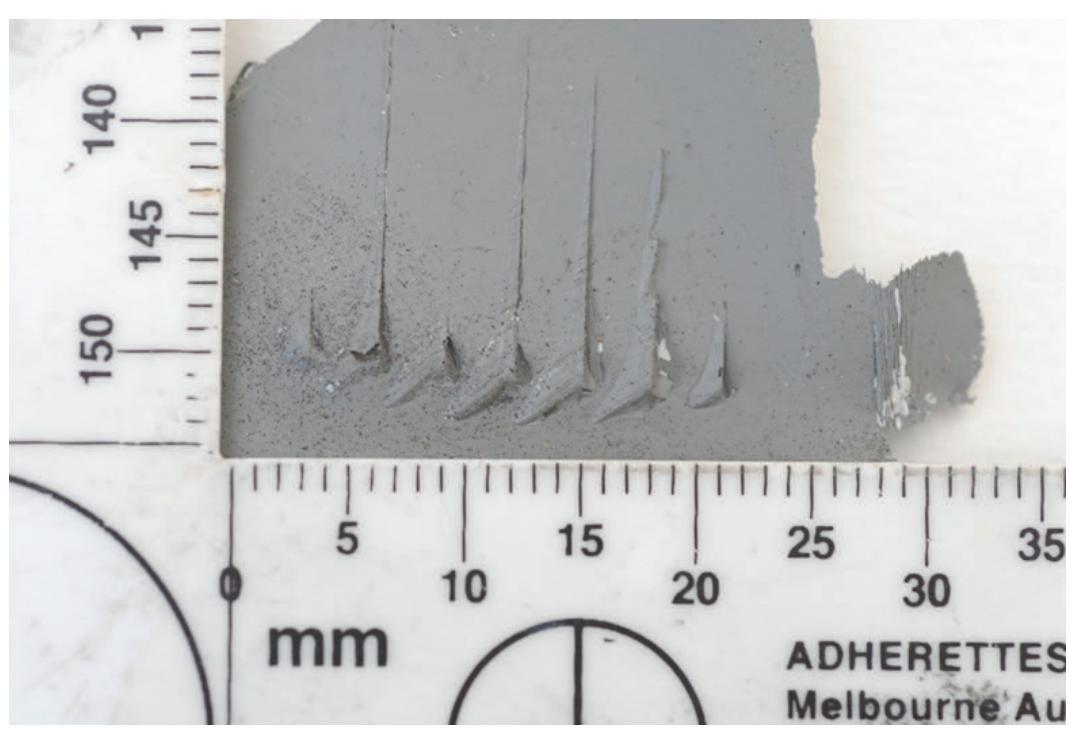
Comparison of test to test tool mark casts showed that fine striated individual characteristics were produced within the impressed marks, and ran perpendicular to the width of the front tooth. Notably, these fine striated individual characteristics appeared across multiple teeth where partial impressions of the tooth edges were observed, with different striated markings visible on each tooth (Figure 14). The appearance of the test tool mark casts was consistent with the appearance of the tool marks in the exhibit cast, which also exhibited combination impressed/striated tool marks from the biting and movement of the teeth when contacting the metal. Some variation was noted between the tests and exhibit tool marks which was determined to be caused by the angle of attack, positioning of the spreader, or movement of the thick powder coating on the ATM body causing slippage during the application of the spreader.

Figure 14: A cast of a test tool mark produced by the EFORCE device when used as a spreader on the test ATM. Individual striae are present amongst the combination tool marks across the edges of multiple teeth

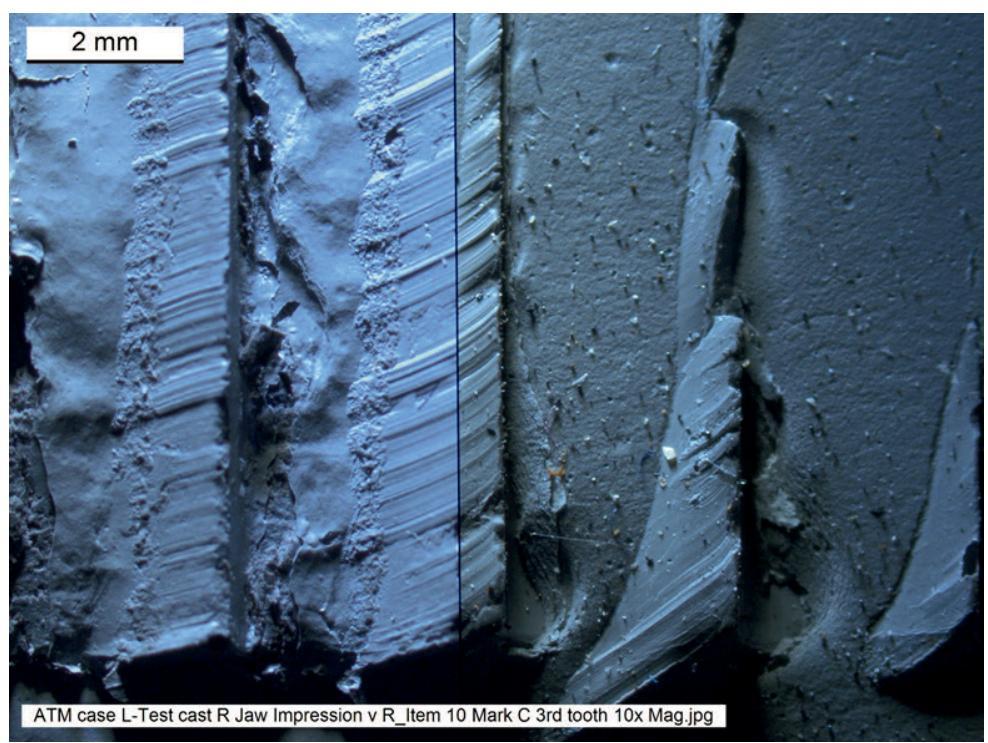
Comparison of the test tool mark casts to the casts from the ATM confirmed that the EFORCE device was the tool that was used to successfully breach some of the ATMs. Not only was there sufficient agreement of individual characteristics along the impression of the front tooth from the spreader but striated tool marks produced by several teeth along the jaw were also in excellent agreement (**Figures 15 and 16**).

Figure 15: A comparison between test combination tool mark casts and exhibit casts taken from an ATM, with agreement seen between random striae from one of the teeth formed as part of the combination impressed and striated tool marks on both casts

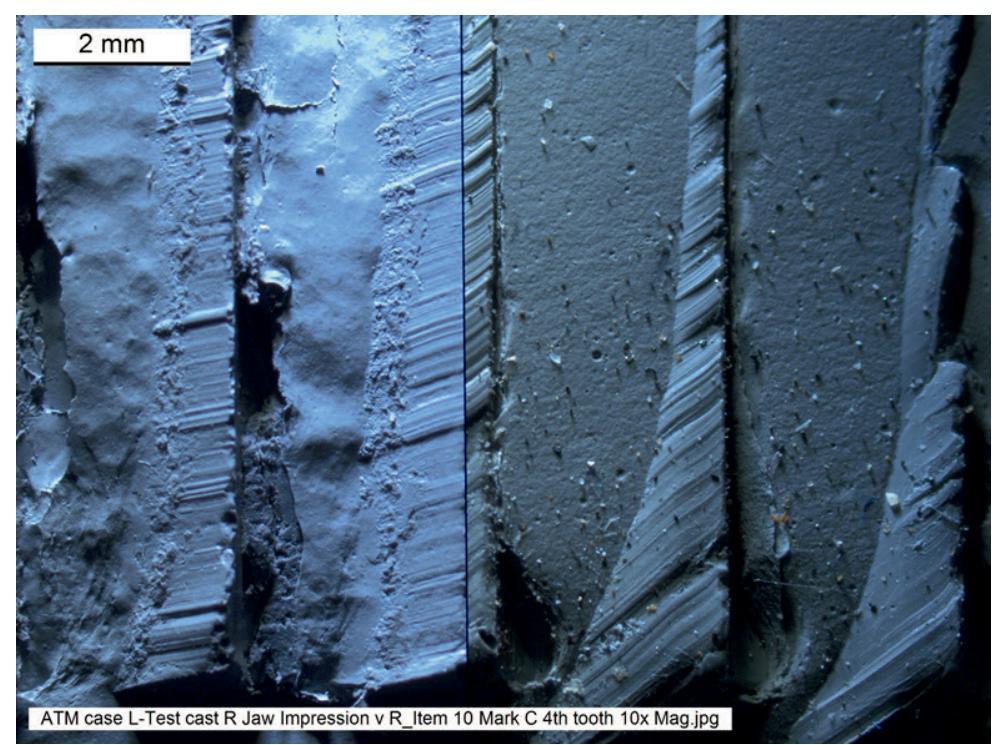
Figure 16: Another comparison between test combination tool mark cast and exhibit cast taken from an ATM, with agreement seen with the individual striae on the subsequent tooth on both casts
