## BREECH FACE MARKS OF THE BRYCO ARMS MODEL JENNINGS NINE

By: Chris Monturo, Miami Valley Regional Crime Laboratory, 361 W. Third St., Dayton, OH 45402

### Abstract

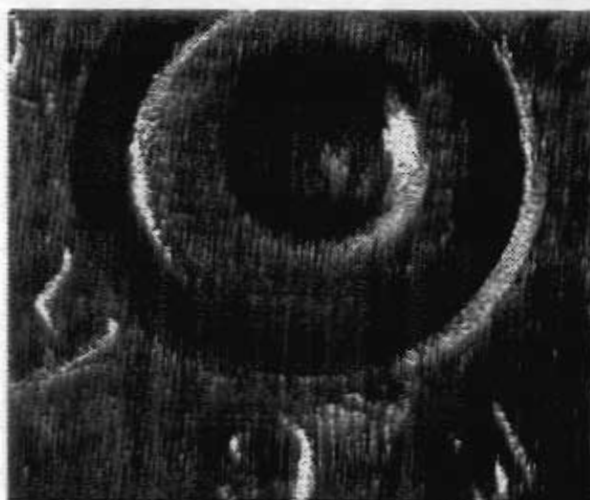
Photo 6: Cartridge casing from the Bryco model Jennings Nine. (Note the ejector mark in the six o'clock position between the "9" and the "m")

Test fired cartridge casings from the Jennings Nine revealed a distinct ejector mark. (See photo #6) All six of the models examined at the gun store had the same rough feeling ejector; however, test fires could not be obtained from those. Further testing with the evidence gun using twenty rounds each of 9mm 115 grain ball Remington, CCI, Federal, Fiocchi, and Winchester failed to reveal the primer bulge on any of the casings as noted with the Bryco 59.<sup>1,2</sup> Class characteristics with respect to the rifling has not changed.
