A Tool Mark Identification Involving Rescue Equipment Used in a Series of Burglaries

By: Sergeant Andrew Nisbet, Ballistics Unit, Victoria Police Forensic Services Centre, Macleod, Melbourne, Australia

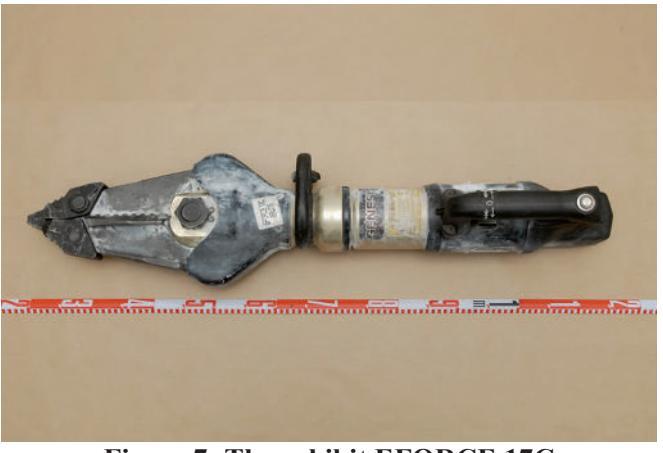
Submitted with the tools was a Genesis Rescue Systems manufactured, EFORCE 17C "BRUTE" model industrial spreader and cutter (**Figure 7**). The EFORCE 17C is a device that serves as heavy rescue equipment.

Figure 7: The exhibit EFORCE 17C "BRUTE" model industrial device

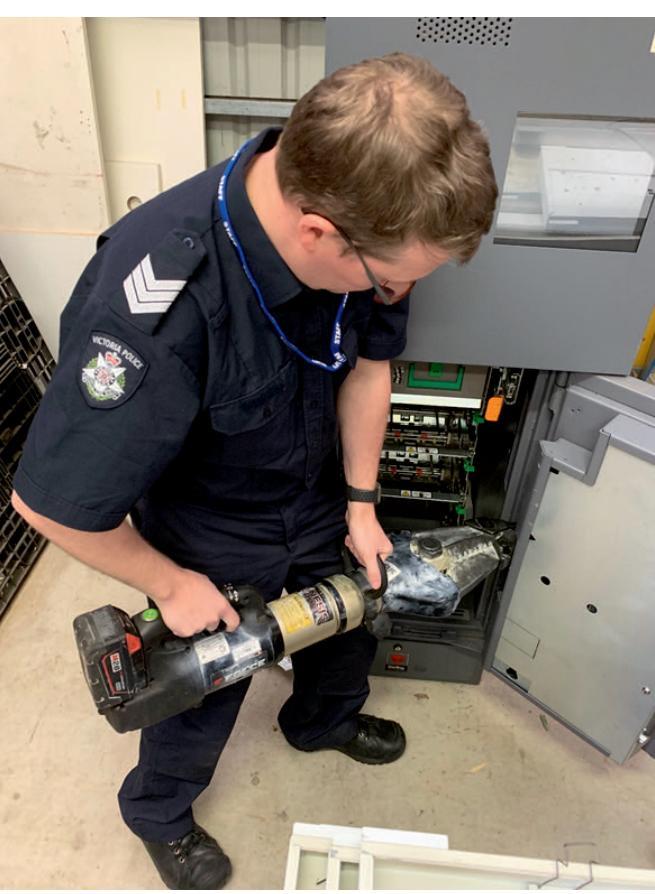
Through consultation with the investigators and the bank whose ATMs had been targeted, a decommissioned ATM body was installed at the Victoria Police Forensic Services Centre (VPFSC) to assist with capturing test tool marks in a similar material. Test tool marks were made in the door and body of this ATM using the EFORCE device as a spreader (Figure 13). These test tool marks were then cast with Forensic Sil for

Figure 13: The author making test impressions with the EFORCE device in an ATM provided and installed at the VPFSC to assist with testing. Both the tool and the substrate used for tests are not commonly encountered
