Examination of Toolmarks from Sequentially Manufactured Tongue-and-Groove Pliers

REFERENCE: Cassidy, F. H., "Examination of Toolmarks from Sequentially Manufactured Tongue-and-Groove Pliers," *Journal of Forensic Sciences*, JFSCA, Vol. 25, No. 4, Oct. 1980, pp. 796-809.

ABSTRACT: Tongue-and-groove pliers are often used in burglaries to twist off door-knobs (to gain entrance) and it was deemed necessary to determine if new, sequentially manufactured pliers would each produce similar toolmarks that would be indistinguishable. Evaluation of the toolmarks from three sets of sequentially broached Craftsman® pliers, together with an analysis of the manufacturing processes, verified that individual and not repetitive structural characteristics are generated.

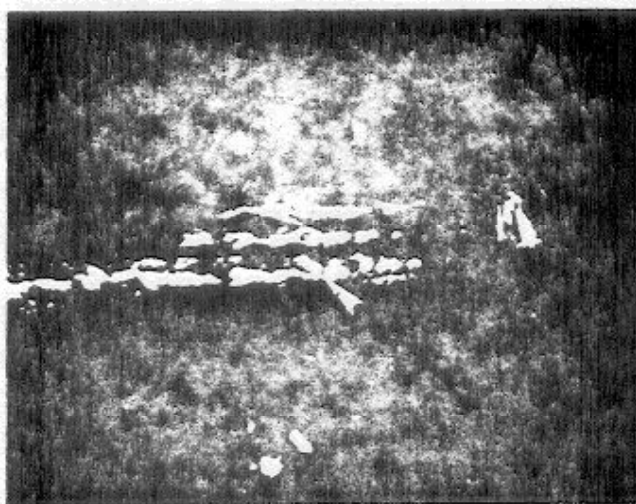
FIG. 1—Comparison of nodular impressions from the Craftsman tongue-and-groove pliers with those found on the doorknob. The lower arrow points to the impression made at the laboratory; the top arrow points to a double impression found on the doorknob. The double impression appears to have been caused by the same nodule but by a slight repositioning of the pliers.

No information was found in the forensic science literature concerning toolmark evaluations of consecutively manufactured tongue-and-groove pliers. The desirability of knowing whether toolmarks produced by sequentially manufactured pliers of this type were unique became necessary when an essentially new Craftsman® pliers and broken doorknobs were submitted to the California Department of Justice Regional Criminalistics Laboratory in Santa Barbara. One of the doorknobs had small, dimpled impressions where it had been gripped. Examination of the pliers with a stereomicroscope revealed numerous nodules on the teeth of the pliers. Some of the nodules appeared to be mirror images of the dimpled area of the doorknob (Fig. 1). By using these nodules as an index, the striations produced by the pliers could be matched to the doorknob striations. Subsequently, Sears, Roebuck and Co. were contacted to request the essential manufacturing data from their supplier to clarify whether the same nodule orientation could be produced on consecutively manufactured pliers.

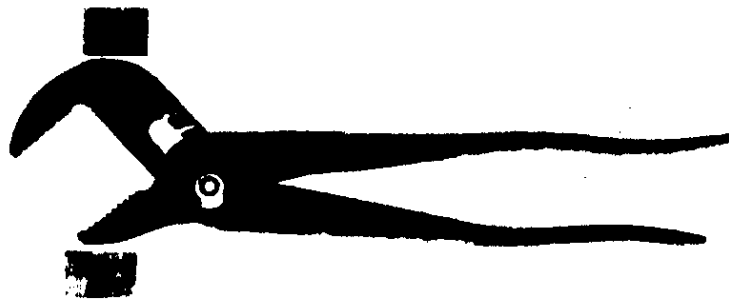
FIG. 2—One of the as-broached tongue-and-groove pliers received from Western Forge Corp.

The only portions of the manufacturing sequence that might possibly produce family characteristics are the forging and the step-broaching, but the forging surface of the tool's gripping area is removed by the broaching. After the broaching, the parts are handled in hatches and it is impossible to follow individual parts through the process. To aid the evaluation of the pliers in the laboratory, Western Forge supplied the Santa Barbara Regional Laboratory with three sets of upper and lower jaws that were sequentially broached after forging with no other manufacturing steps as well as three sets of upper jaws that had gone through the complete manufacturing process at approximately the same time as the as-broached jaws. Figure 2 is a photograph of one of the pliers. The upper and lower jaws are designated.

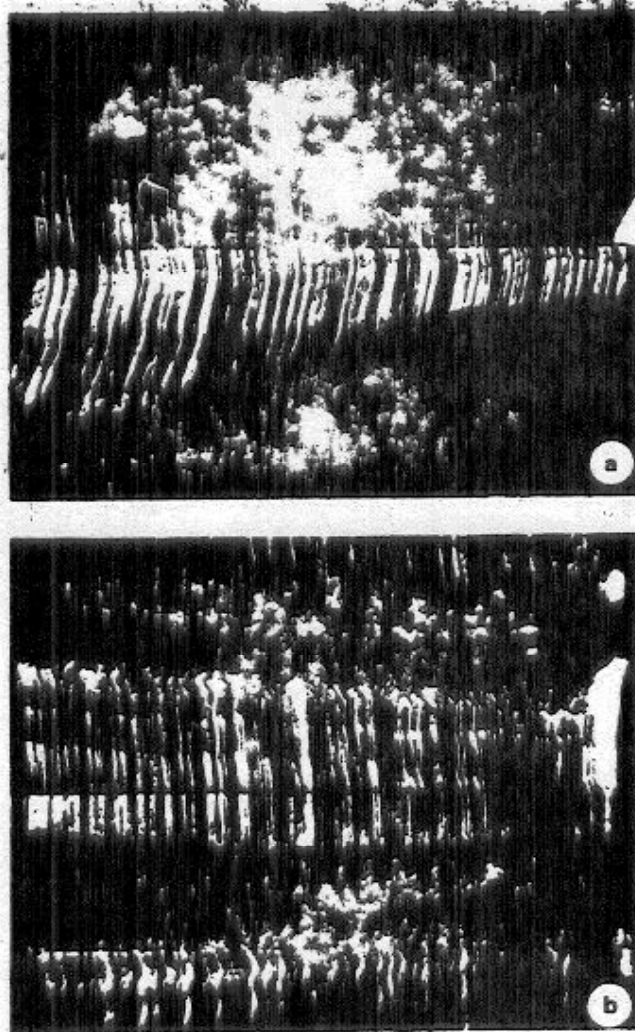
FIG. 10—Photomicrographs of toolmark striations from the chromium-plated jaws, demonstrating reproducibility: (a) Pliers 1, top jaws and (b) Pliers 2, top jaws.

Replicate samples of the individual striation patterns of the upper jaw of as-broached Pliers 1 and 2 are compared in Figs. 9a and 9b. Similar patterns for two of the finished jaws (the chromium-plated jaws) are shown in Figs. 10a and 10b. Each photomicrograph shows striations produced by the same tooth area when it is twisted in the same direction (as previously described). These figures demonstrate that the toolmark striations caused by the imperfection of the as-broached jaws and of the finished jaw can readily be compared to themselves when the striations are produced at different times.

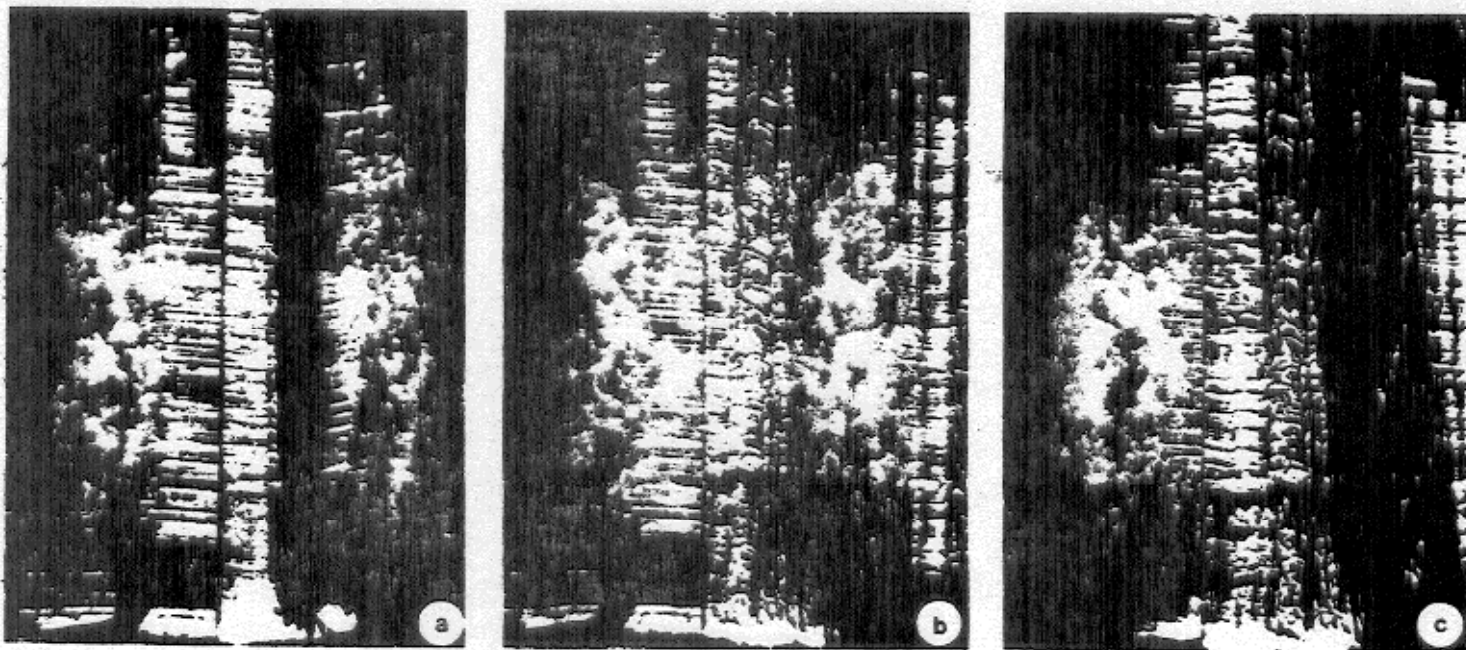
FIG. 11—Photomicrographs of toolmark striations from the as-broached jaws showing individuality of specific teeth: (a) Pliers 1 and 2, (b) Pliers 1 and 3, and (c) Pliers 2 and 3.

When toolmark striation patterns of similar tooth locations of one jaw are compared to the next consecutively broached jaw, there is no identical pattern of striations. Figures 11a, 11b, 11c compare the same tooth of, respectively, the upper as-broached jaw of Jaw 1 to Jaw 2; 1 to 3; and 2 to 3. Each jaw produces unique striations that do not match

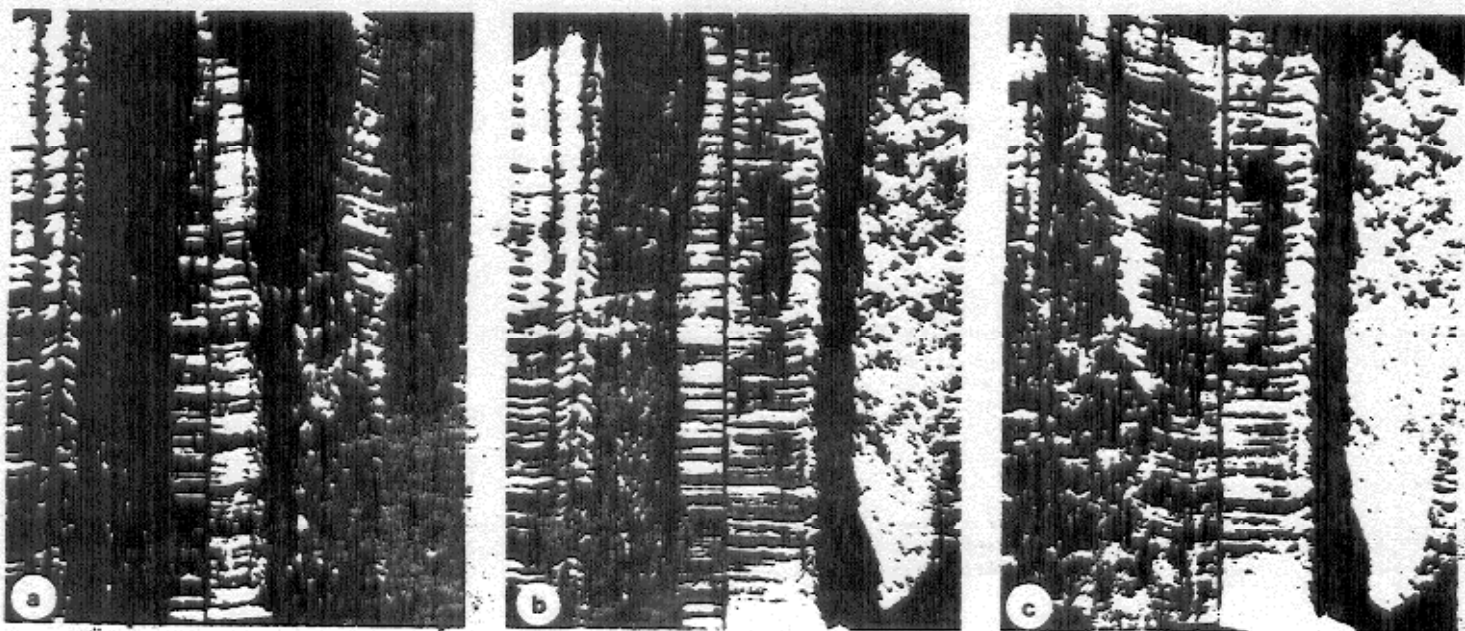
FIG. 12—Photomicrographs of toolmark striations from the chromium-plated jaws showing individuality of specific teeth: (a) Pliers 1 and 2, (b) Pliers 1 and 3, and (c) Pliers 2 and 3.

the other jaw striations. Similarly, Figs. 12a, 12b, and 12c likewise compare the same tooth areas on the as-finished jaws with the other as-finished jaws and no identifying matches exist here, either.

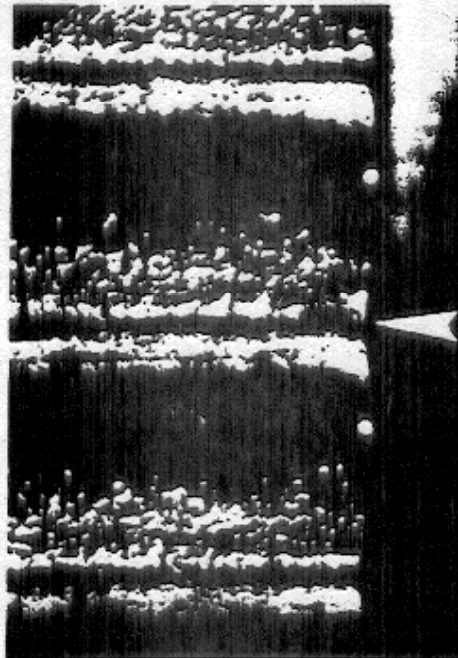
FIG. 13—Damaged tooth area on one of the completely processed jaws. This dent was probably caused by striking another jaw during processing subsequent to broaching.

5. Several thousand jaws are handled together for additional processing after the broaching. During this operation and during the de-scaling tumbling, it is possible that some of the parts themselves strike one another, thus leaving individualistic dents. It is thought that the imperfection on the tooth edge shown in Fig. 13 is such a dent. (This imperfection is on a tooth apex of one of three electroplated jaws received from Western Forge Corp.)

7. The electrodeposited nickel and chromium will produce varying degrees of roughness because the plating is deposited on a mechanically de-scaled surface having varying surface irregularities. Electrodeposited coatings will preferentially plate on high points—such as a tooth apex—exaggerating the surfaces they are deposited on [9, pp. 432-443]. This buildup tends to produce microscopic nodules as can be observed in Figs. 7 and 13. These nodules will produce unique striations when the plated teeth deform a softer surface.

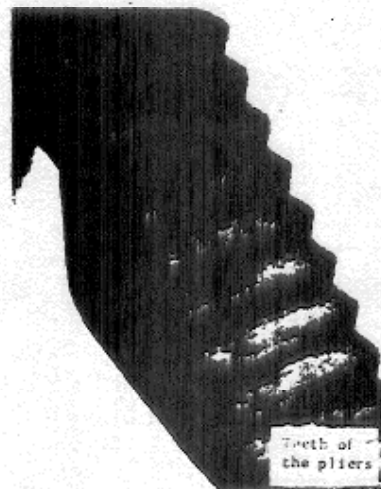
Path of travel of the stepped broach that would produce repetitive structural characteristics if they could be produced.

Normal travel direction of twist when the tool causes striations.

FIG. 14—The striations caused by using the tool are 90 deg from the direction of the potential repetitive structural characteristics that would be produced, if possible, by the broaching tool. The photograph shows one of the as-broached jaws.

8. If the broaching tool could produce repetitive structural characteristics they would be produced along the direction of travel of the tool. But striations caused by tool usage are 90 deg from that direction. Figure 14 is a diagrammatic representation of this phenomenon.
